THE CLINICAL PICTURE

A second-degree burn after MRI

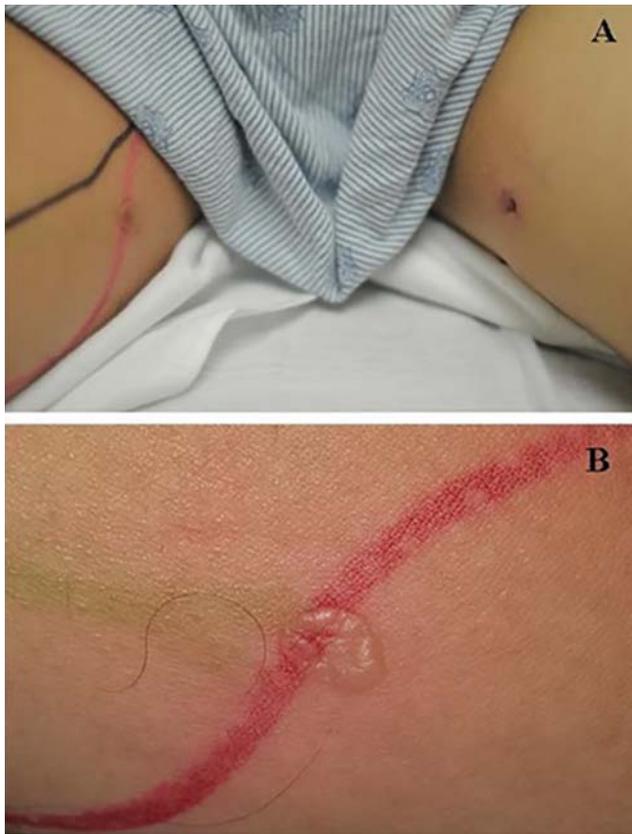
FIGURE 1. (A) Articulating 1-cm lesions developed after magnetic resonance imaging. The black and red tracings on the right inner thigh indicate the original area of cellulitis. (B) A bullous lesion with clear serous fluid on the right medial thigh.

After the procedure, the patient was noted to have a bullous lesion on each thigh, each lesion roughly 1 cm in diameter and filled with clear serous fluid (Figure 1). He reported that his legs had been pressed together before entering the MRI machine and that he had felt a burning sensation in both thighs during the test. Examination confirmed that the lesions indeed aligned with each other when he pressed his thighs together.

We believe that during placement in the scanner, our patient inadvertently moved his

thighs together, forming a closed loop conduction circuit and resulting in a thermal burn.

This case illustrates the importance of correct positioning during MRI. The MRI technicians had taken standard precautions, placing a sheet over the patient and ensuring no direct contact with the radio-frequency transmitter receiver (MR unit). However, precautions against skin-to-skin contact were not taken, and the patient's legs were not separated.

Appropriate positioning prevents closed skin-to-skin loops, but this may be more challenging in a larger patient.⁶ While the patient is in the scanner, a “squeeze ball” alert system allows the patient to signal the technologist should unexpected distress or heating occur.^{6,7} A patient's inability to utilize the squeeze ball contributes to the risk of a severe injury. Further, in this instance, there may have been a language barrier. Also, proximity of the anatomic skin-to-skin loop to the imaged body part (and therefore the center of the MRI coil) may have conferred risk related to field strength in this patient.

The MRI technologist, under supervision of a radiologist, is primarily responsible for positioning the patient to decrease the risk of this complication and for following institutional MRI safety protocols and professional guidelines.⁶⁻⁸ MRI technologist certification training highlights all aspects of safety, including skin-to-skin conducting loop prevention.^{7,8}

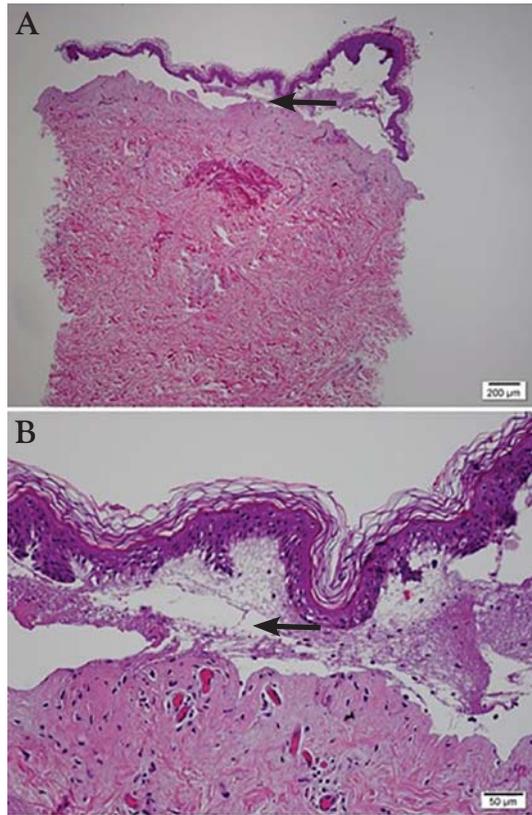
Study of a biopsy of one of the lesions revealed subepidermal cell blisters with focal epidermal necrosis and coagulative changes in the superficial dermis, consistent with a thermal injury (Figure 2).

FIGURE 2. Focal epidermal necrosis (arrows) and coagulative changes in the superficial dermis were consistent with thermal injury (hematoxylin and eosin; panel A magnification $\times 2.5$; panel B magnification $\times 10$).
