THE CLINICAL PICTURE

A second-degree burn after MRI

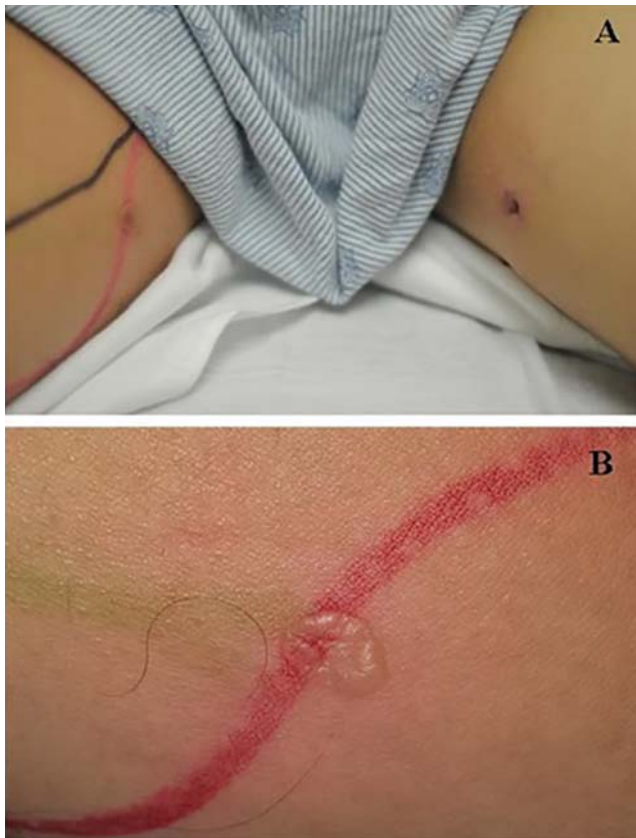
FIGURE 1. (A) Articulating 1-cm lesions developed after magnetic resonance imaging. The black and red tracings on the right inner thigh indicate the original area of cellulitis. (B) A bullous lesion with clear serous fluid on the right medial thigh.

After the procedure, the patient was noted to have a bullous lesion on each thigh, each lesion roughly 1 cm in diameter and filled with clear serous fluid (Figure 1). He reported that his legs had been pressed together before entering the MRI machine and that he had felt a burning sensation in both thighs during the test. Examination confirmed that the lesions indeed aligned with each other when he pressed his thighs together.

We believe that during placement in the scanner, our patient inadvertently moved his

thighs together, forming a closed loop conduction circuit and resulting in a thermal burn.

This case illustrates the importance of correct positioning during MRI. The MRI technicians had taken standard precautions, placing a sheet over the patient and ensuring no direct contact with the radio-frequency transmitter receiver (MR unit). However, precautions against skin-to-skin contact were not taken, and the patient's legs were not separated.

Appropriate positioning prevents closed skin-to-skin loops, but this may be more challenging in a larger patient.⁶ While the patient is in the scanner, a “squeeze ball” alert system allows the patient to signal the technologist should unexpected distress or heating occur.^{6,7} A patient's inability to utilize the squeeze ball contributes to the risk of a severe injury. Further, in this instance, there may have been a language barrier. Also, proximity of the anatomic skin-to-skin loop to the imaged body part (and therefore the center of the MRI coil) may have conferred risk related to field strength in this patient.

The MRI technologist, under supervision of a radiologist, is primarily responsible for positioning the patient to decrease the risk of this complication and for following institutional MRI safety protocols and professional guidelines.^{6–8} MRI technologist certification training highlights all aspects of safety, including skin-to-skin conducting loop prevention.^{7,8}

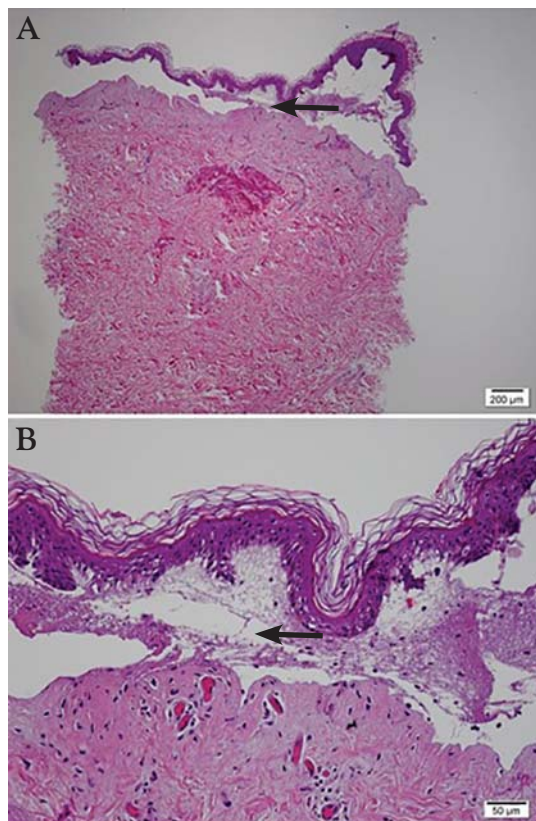
Study of a biopsy of one of the lesions revealed subepidermal cell blisters with focal epidermal necrosis and coagulative changes in the superficial dermis, consistent with a thermal injury (Figure 2).

FIGURE 2. Focal epidermal necrosis (arrows) and coagulative changes in the superficial dermis were consistent with thermal injury (hematoxylin and eosin; panel A magnification $\times 2.5$; panel B magnification $\times 10$).
