LEARNING OBJECTIVE: Readers will recognize and manage malpositioning of cardiac implantable electronic device leads

Detecting and managing device leads inadvertently placed in the left ventricle

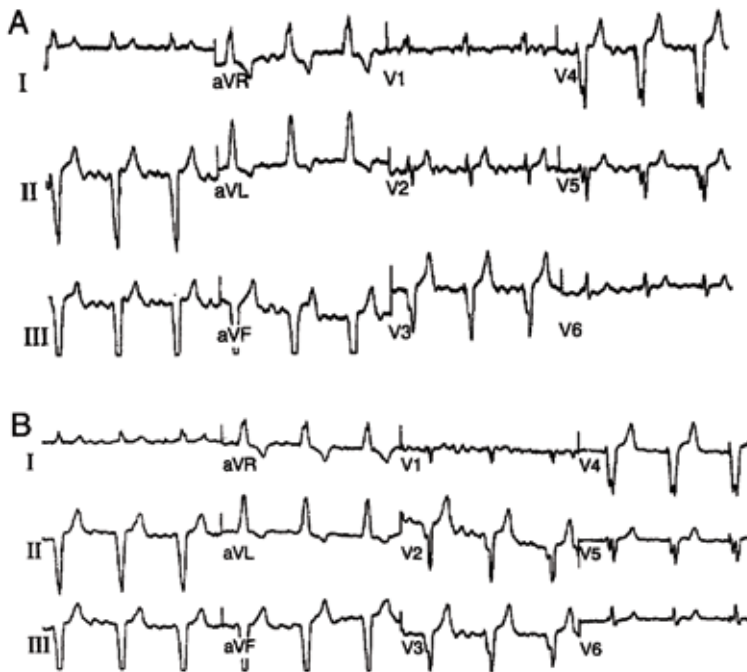
Figure 1. Typical 12-lead electrocardiogram showing right bundle branch block morphology from the right ventricular apex with (A) standard V_1 and V_2 lead positions and (B) return to left bundle branch block morphology after V_1 and V_2 are moved 1 interspace lower than standard.

Klein et al⁷ reported on 8 patients who had features of right bundle branch block in leads V₁ and V₂ and noted that placing these leads 1 interspace lower eliminated the right bundle branch block appearance. The utility of this maneuver is demonstrated in **Figure 1**.
