LEARNING OBJECTIVE: Readers will recognize and manage malpositioning of cardiac implantable electronic device leads

Detecting and managing device leads inadvertently placed in the left ventricle

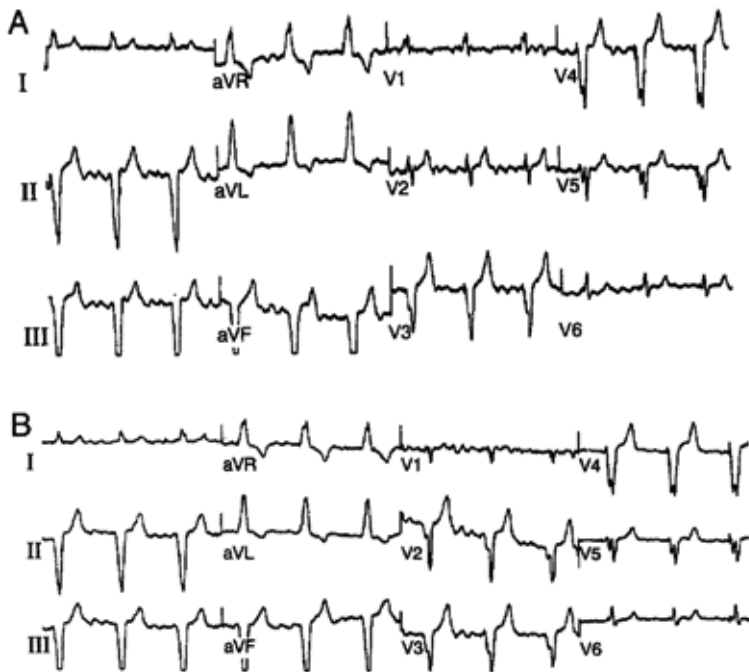
Figure 1. Typical 12-lead electrocardiogram showing right bundle branch block morphology from the right ventricular apex with (A) standard V_1 and V_2 lead positions and (B) return to left bundle branch block morphology after V_1 and V_2 are moved 1 interspace lower than standard.

Klein et al⁷ reported on 8 patients who had features of right bundle branch block in leads V₁ and V₂ and noted that placing these leads 1 interspace lower eliminated the right bundle branch block appearance. The utility of this maneuver is demonstrated in **Figure 1**.

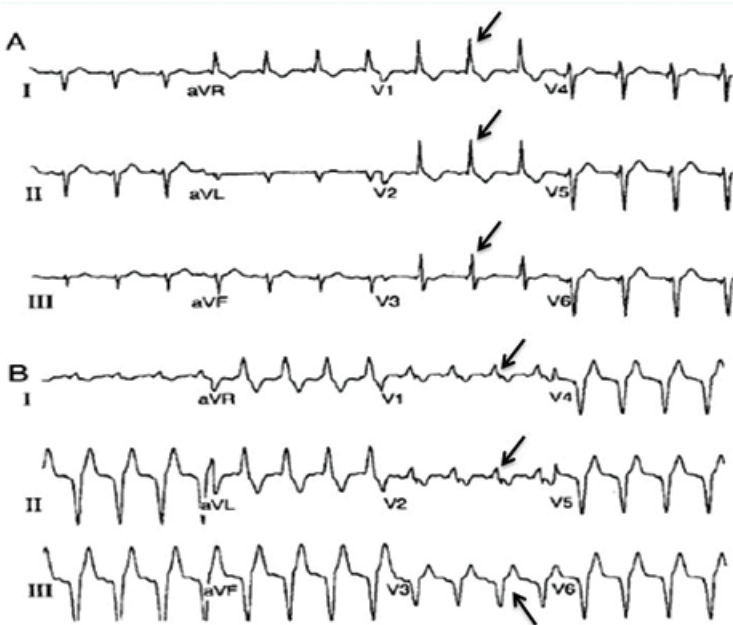
Figure 2. (A) Electrocardiogram from a patient with known left ventricular lead position through a patent foramen ovale. Arrows point to dominant R waves in leads V_1 , V_2 , and V_3 , compatible with left ventricular pacing. (B) The same patient after revision and placement in the right ventricle. Arrows point to dominant R waves in leads V_1 and V_2 , with a precordial transition to a dominant S wave occurring at lead V_3 .

specificity, and positive predictive value 95%). A precordial transition at or before lead V_3 essentially ruled out inadvertent left ventricular pacing (Figure 2).⁹ In addition, criteria were established to distinguish 4 major areas of left ventricular endocardial pacing.⁶

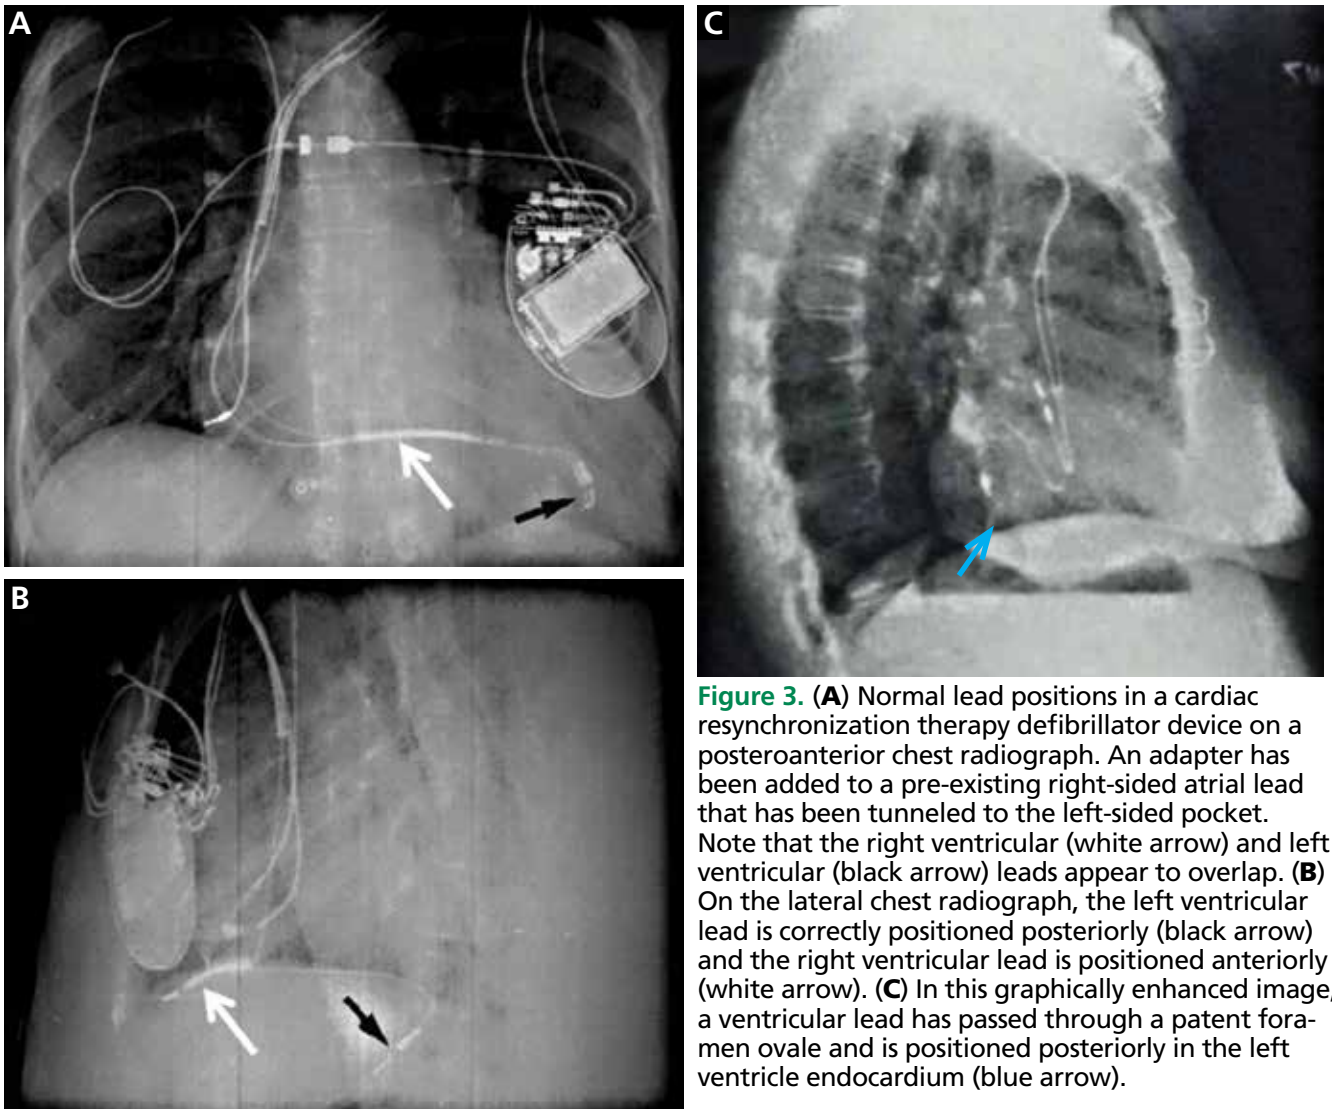
Figure 3. (A) Normal lead positions in a cardiac resynchronization therapy defibrillator device on a posteroanterior chest radiograph. An adapter has been added to a pre-existing right-sided atrial lead that has been tunneled to the left-sided pocket. Note that the right ventricular (white arrow) and left ventricular (black arrow) leads appear to overlap. (B) On the lateral chest radiograph, the left ventricular lead is correctly positioned posteriorly (black arrow) and the right ventricular lead is positioned anteriorly (white arrow). (C) In this graphically enhanced image, a ventricular lead has passed through a patent foramen ovale and is positioned posteriorly in the left ventricle endocardium (blue arrow).

finding on an anteroposterior or posteroanterior chest radiograph. The definitive view is the lateral projection, which is also true during intraoperative fluoroscopy.¹³⁻¹⁵ The tip of a malpositioned left-ventricular lead is characteristically seen farther posterior (toward the spine) in the cardiac silhouette on the lateral view (Figure 3).² If the lead is properly positioned, the general direction of the middle to distal portion should be away from the spine.

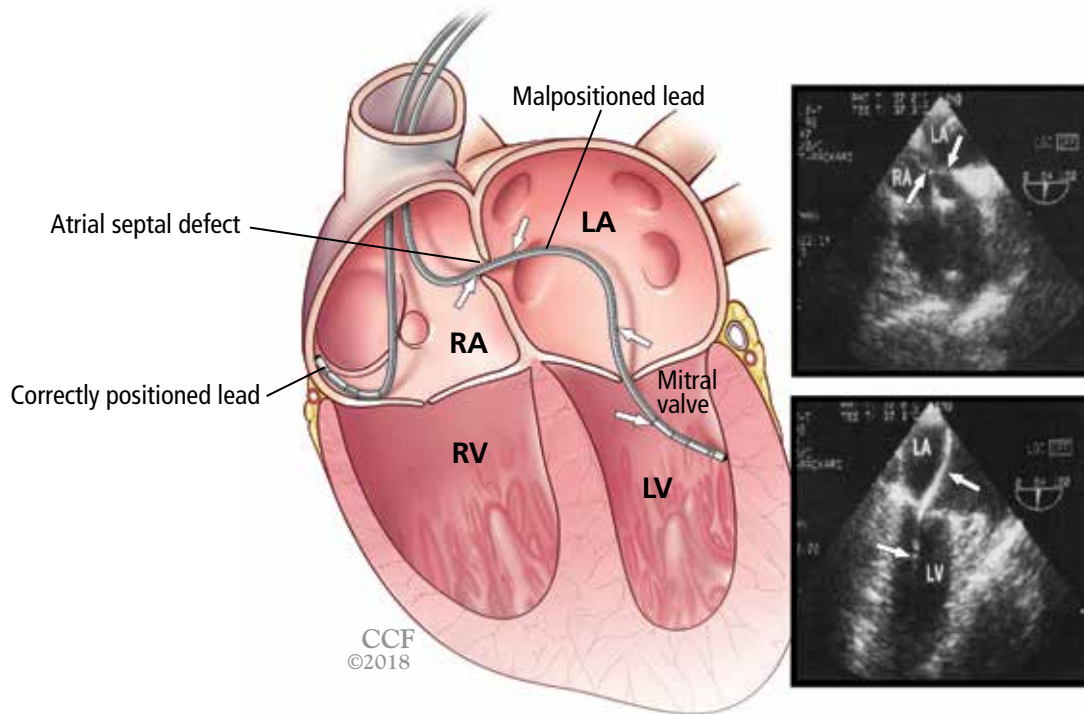
Figure 4. Left, correctly positioned and malpositioned leads. As shown in the transesophageal echocardiogram (right), the malpositioned lead passed through an atrial septal defect (top) through the mitral valve into the left ventricle (bottom).

Although an electrocardiogram and a lateral chest radiograph should suffice to detect inadvertent left ventricular lead placement, it is common to confirm the diagnosis with a 2-dimensional transthoracic or transesophageal echocardiogram (Figure 4).¹⁶
