THE CLINICAL PICTURE

HIROKI MATSUURA, MD

Gas under the right diaphragm

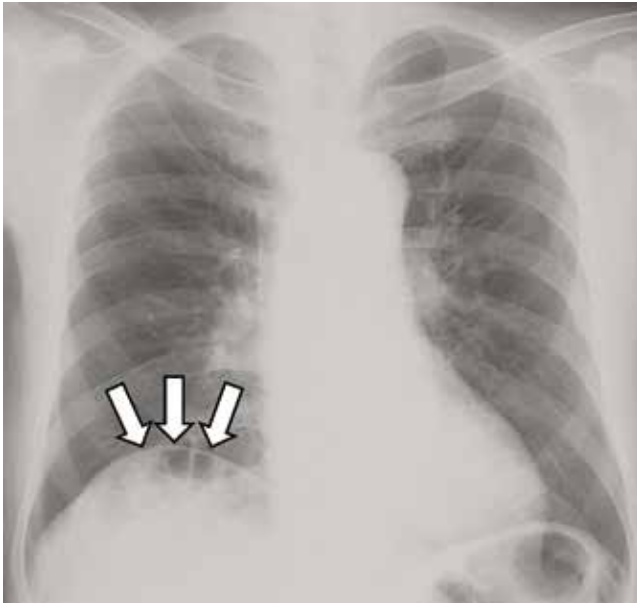
Figure 1. Radiography of the chest with the patient standing showed gas under the right diaphragm (arrows).

His abdomen was mildly tender without guarding or rigidity. The standing chest radiograph showed gas under the right diaphragm (**Figure 1**), and computed tomography (CT) revealed the Chilaiditi sign, with volvulus of the cecum between the diaphragm and liver and a closed-loop obstruction (**Figure 2**).

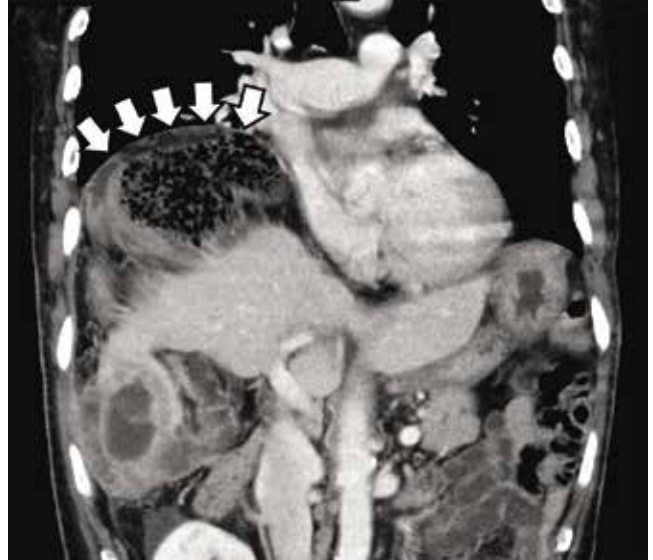
Figure 2. The Chilaiditi sign on computed tomography, with volvulus of the cecum between the diaphragm and liver and a closed-loop obstruction (arrows).

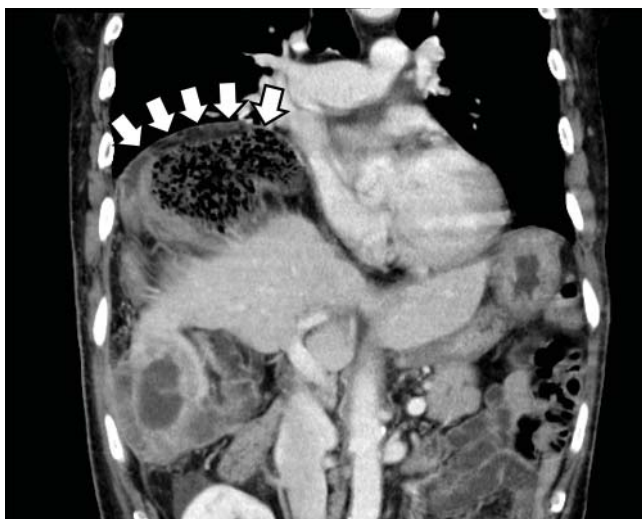
Figure 2. The Chilaiditi sign on computed tomography, with volvulus of the cecum between the diaphragm and liver and a closed-loop obstruction (arrows).

In the article “Gas under the right diaphragm” (Matsuura H, Hata H. *Cleve Clin J Med* 2018; 85[2]:98–100), **Figure 2** appeared upside down. It should have appeared as follows:
